BUREAU OF SHIPS GROUP
TECHNICAL INSPECTION REPORT

⑥ OPERATION CROSSROADS.
U.S.S HUGHES (DD410).
TEST BAKER.

VOLUME II [u] ⑧

USS HUGHES (DD410)

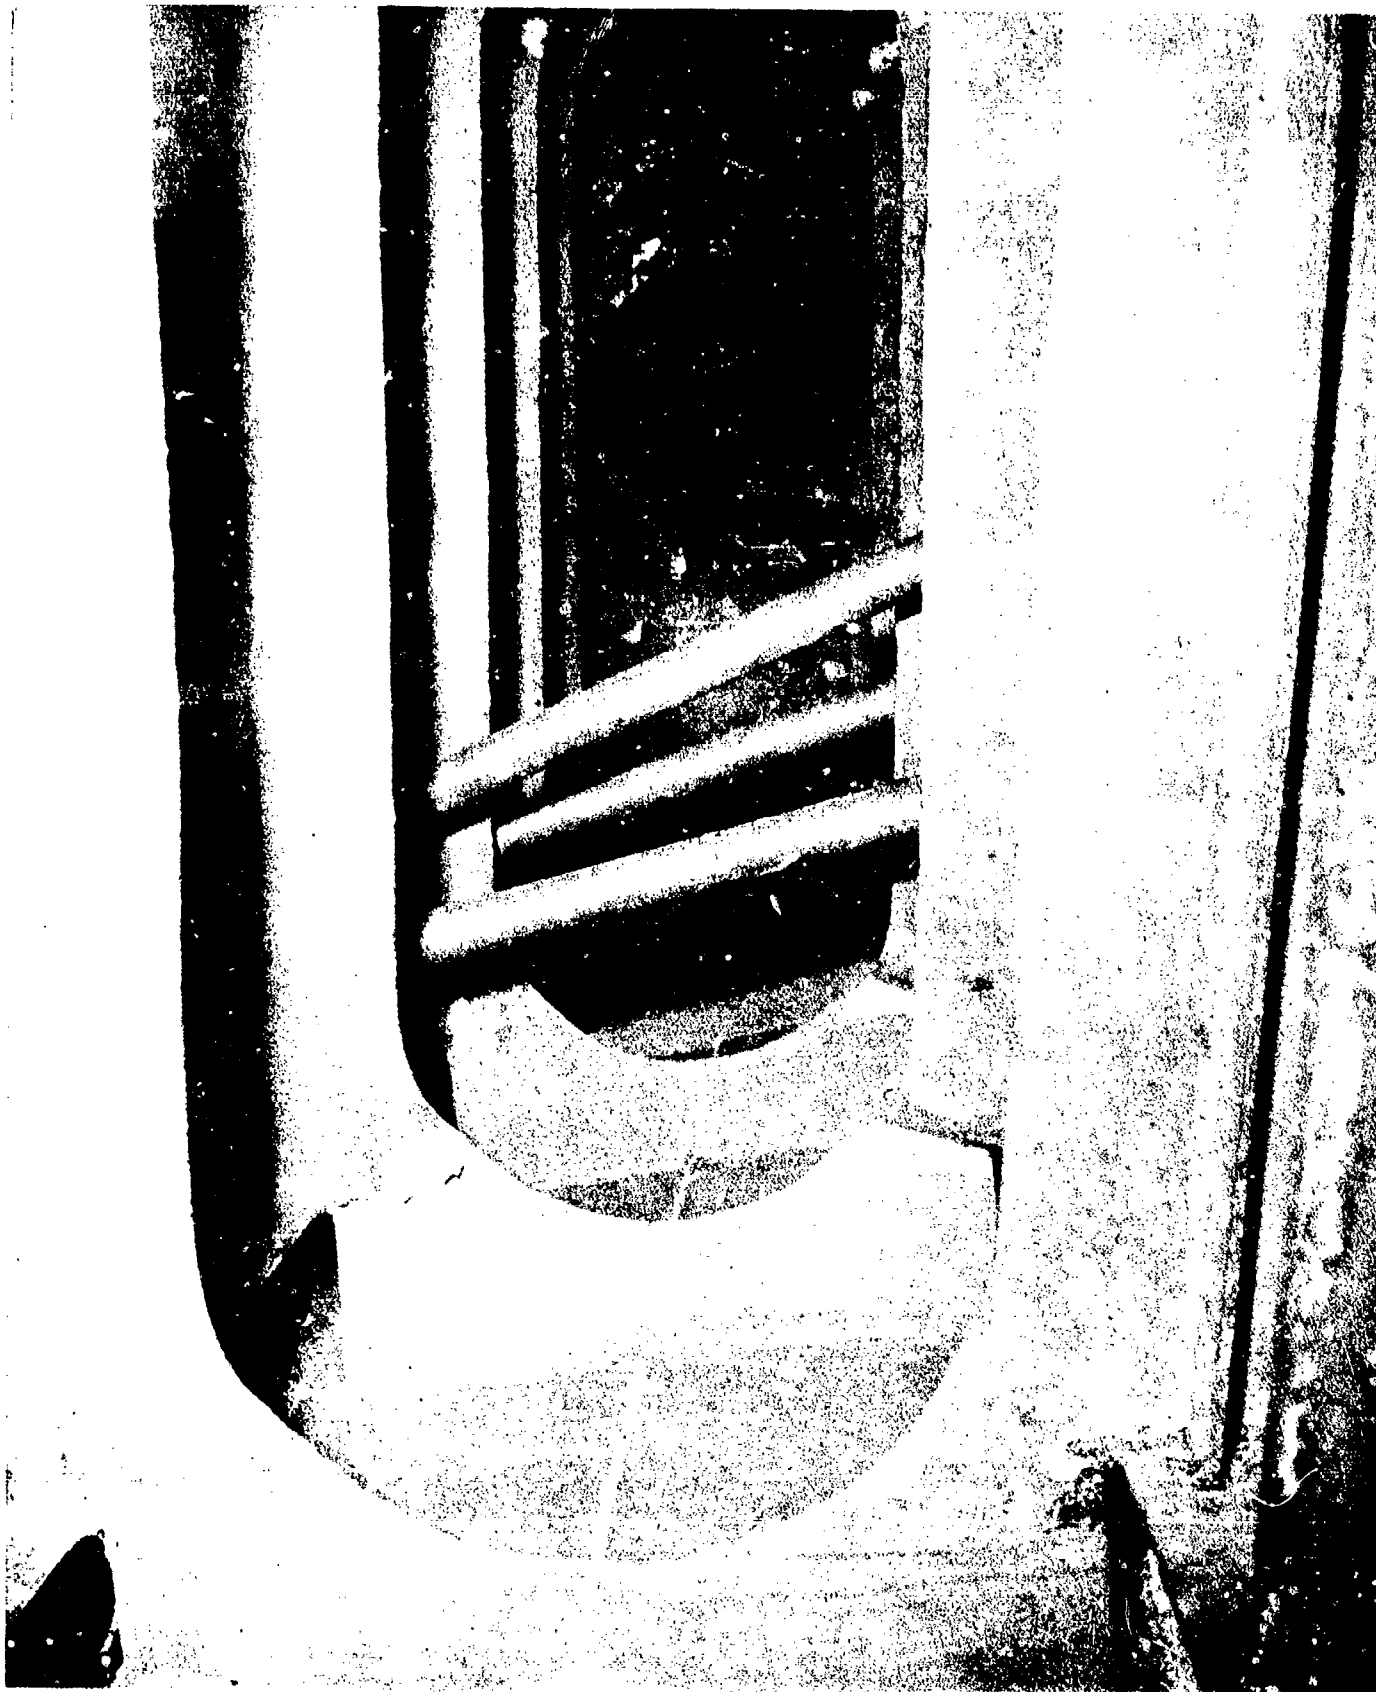
AB-CR-234-4061-3. A-401W. Buckling of floors in peak tank, bulkheads 6 to 14, looking aft about 4 feet above keel.

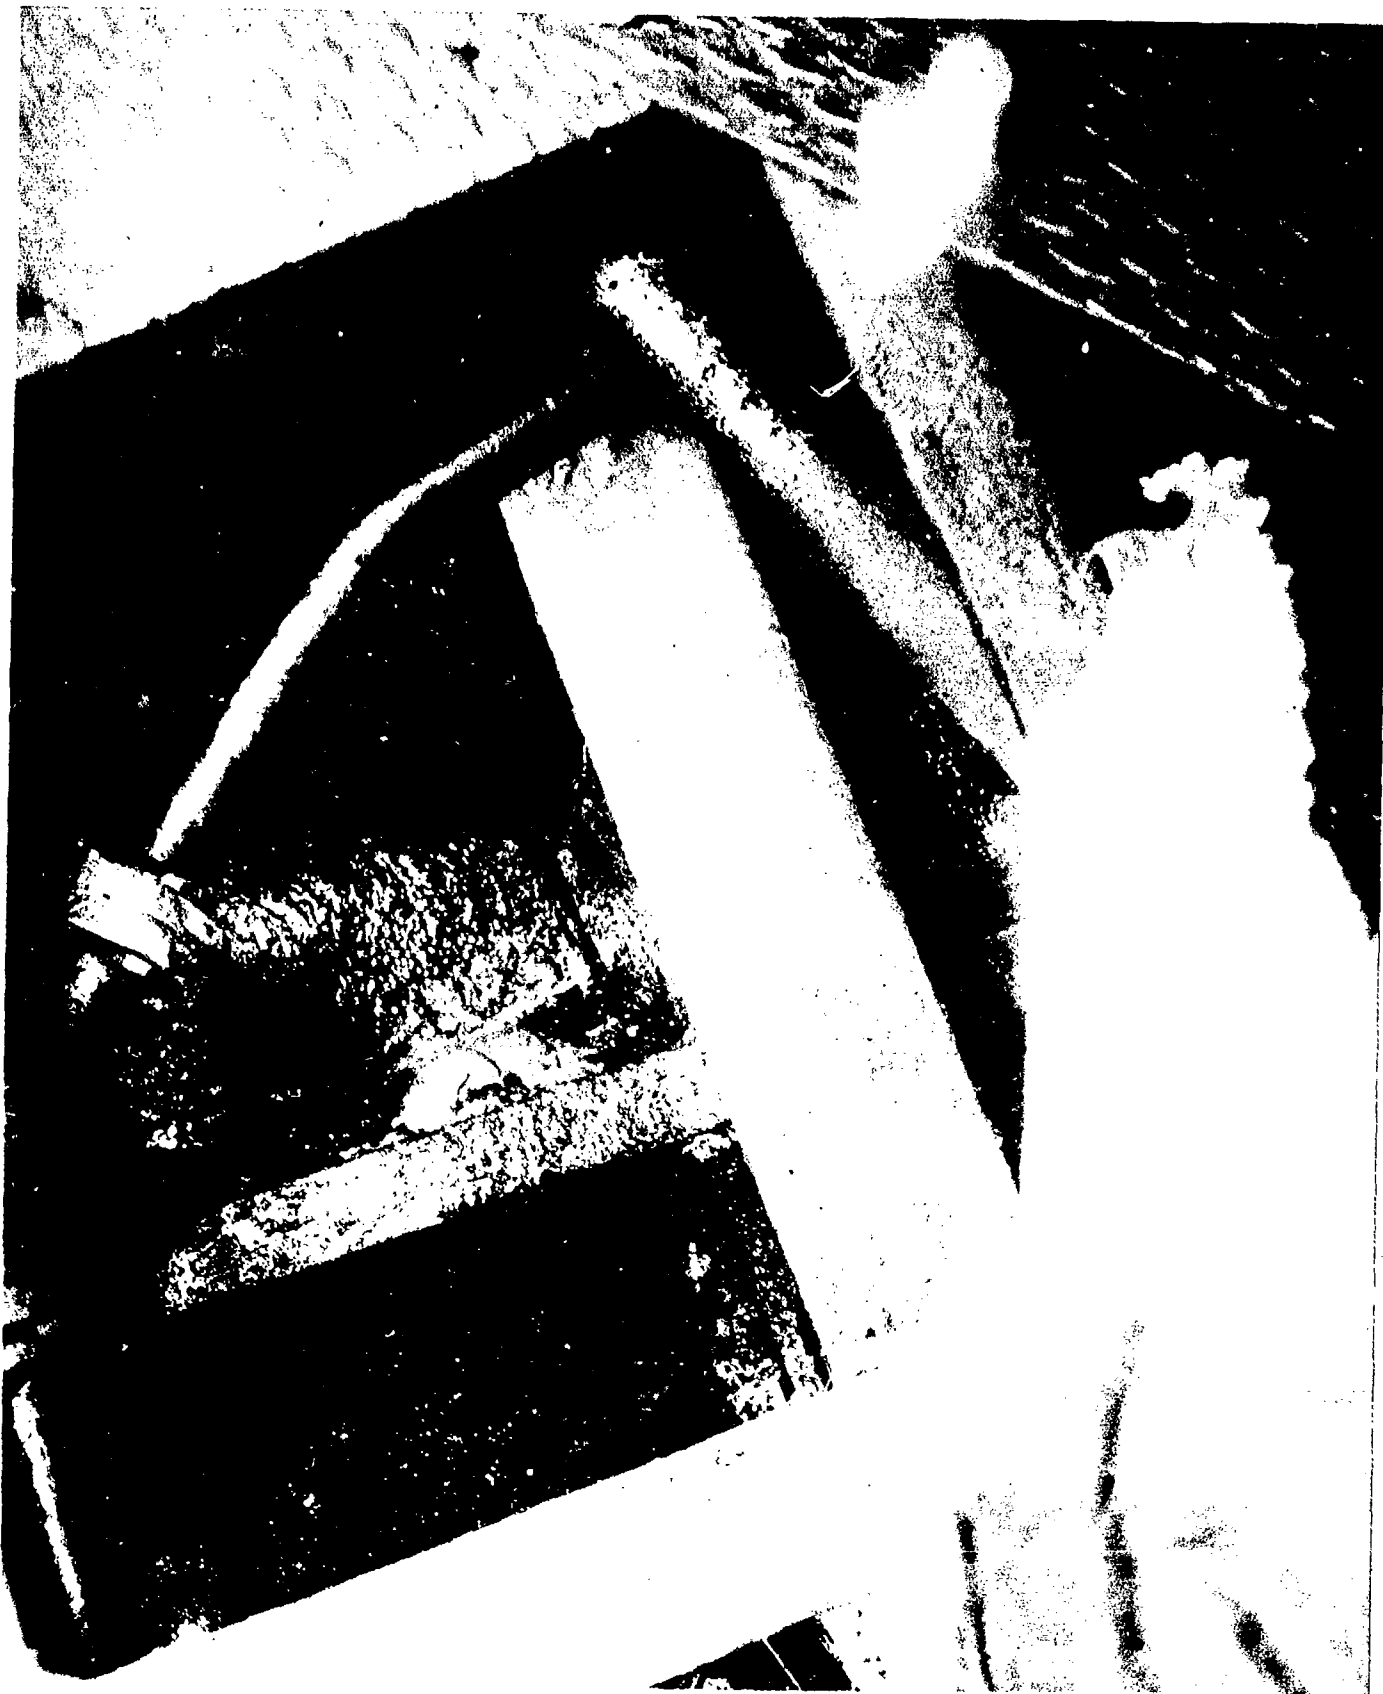
AB-CR-234-4061-7. Forward fire room B-1-1, buckle in web frame 78, about 8 feet to starboard of centerline, looking down.

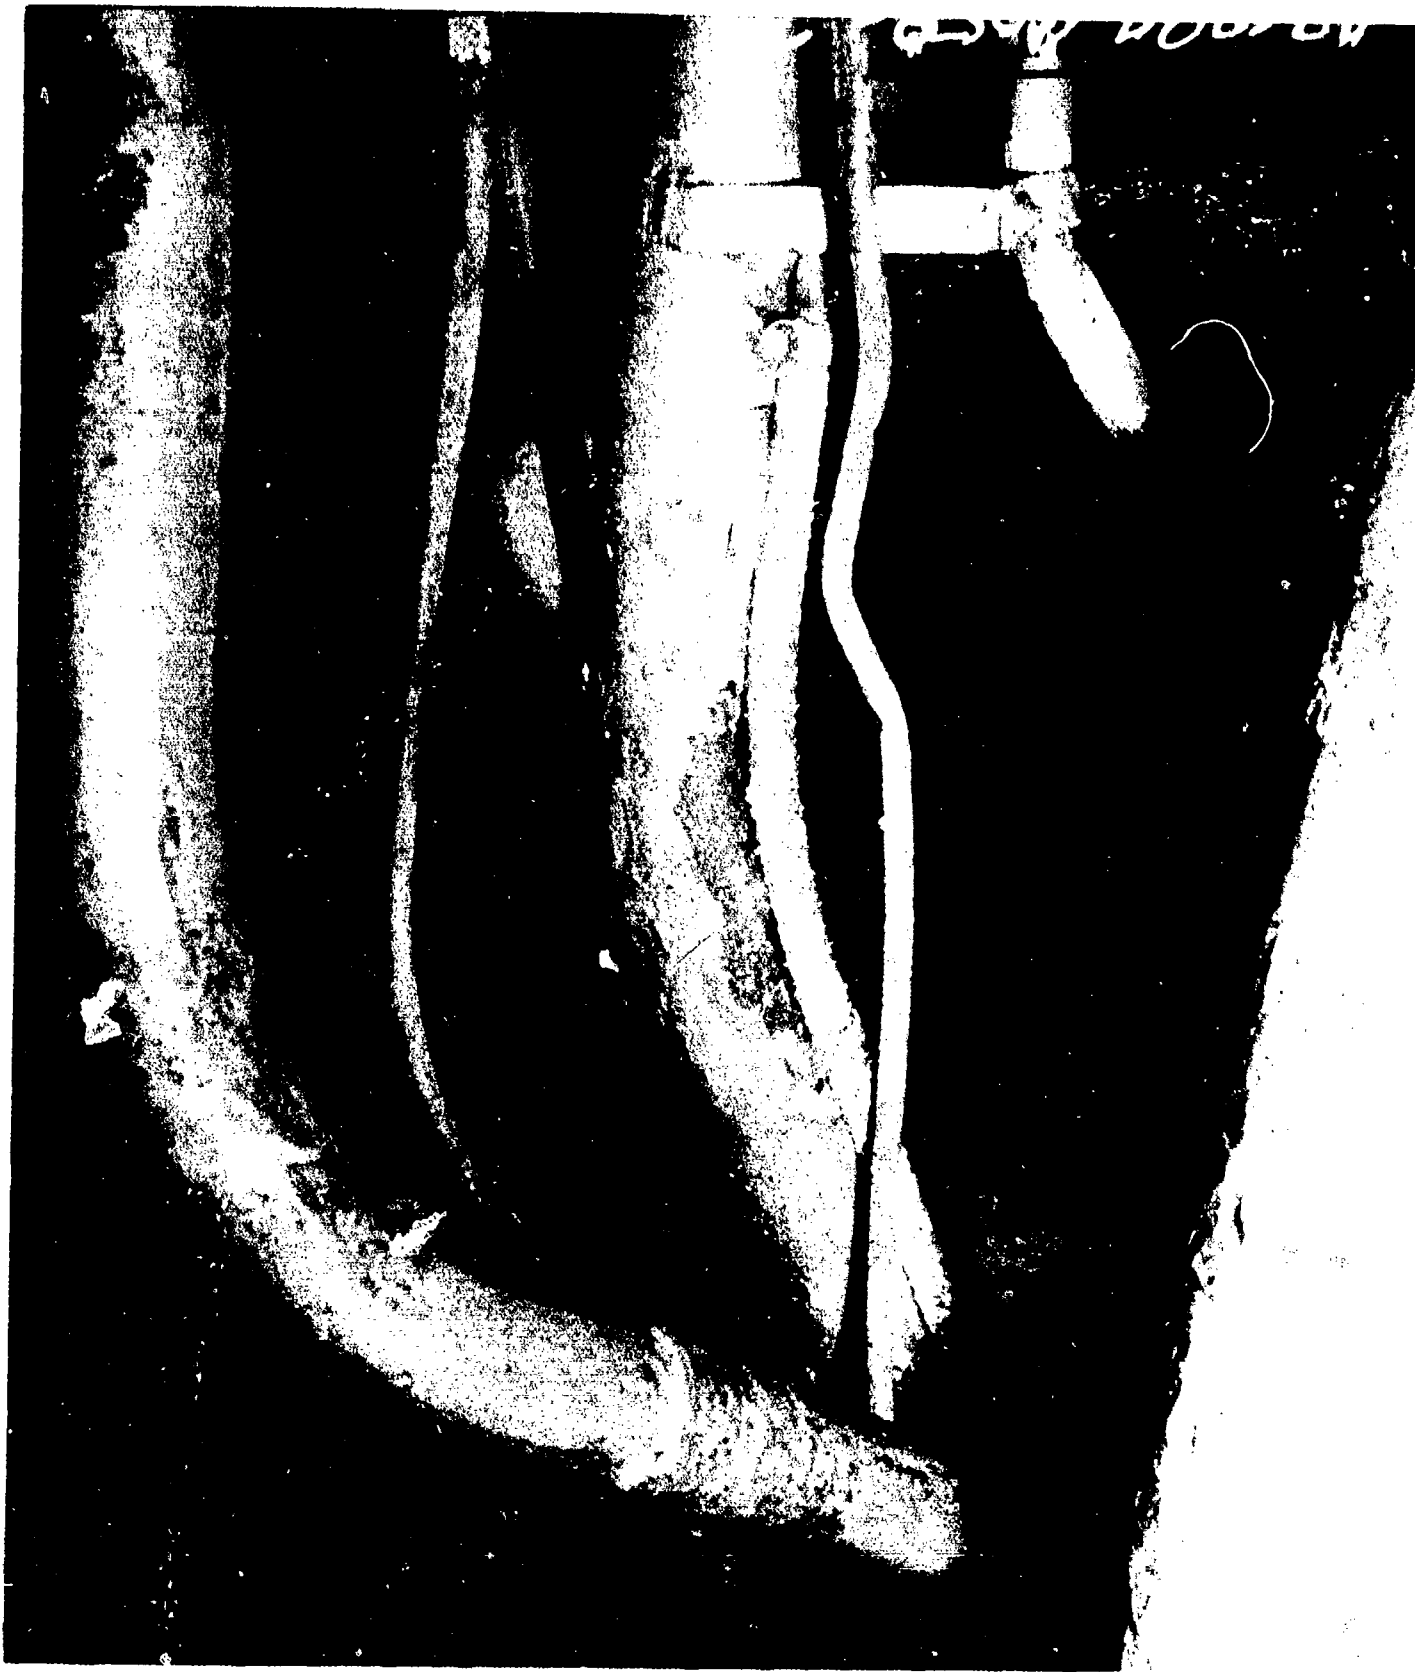
AB-CR-97-4058-2. Aft engine room, B-4-1. The center 3 1/2" diameter pipe is a buckled surge tank support located at starboard of centerline at frame 129, looking aft.

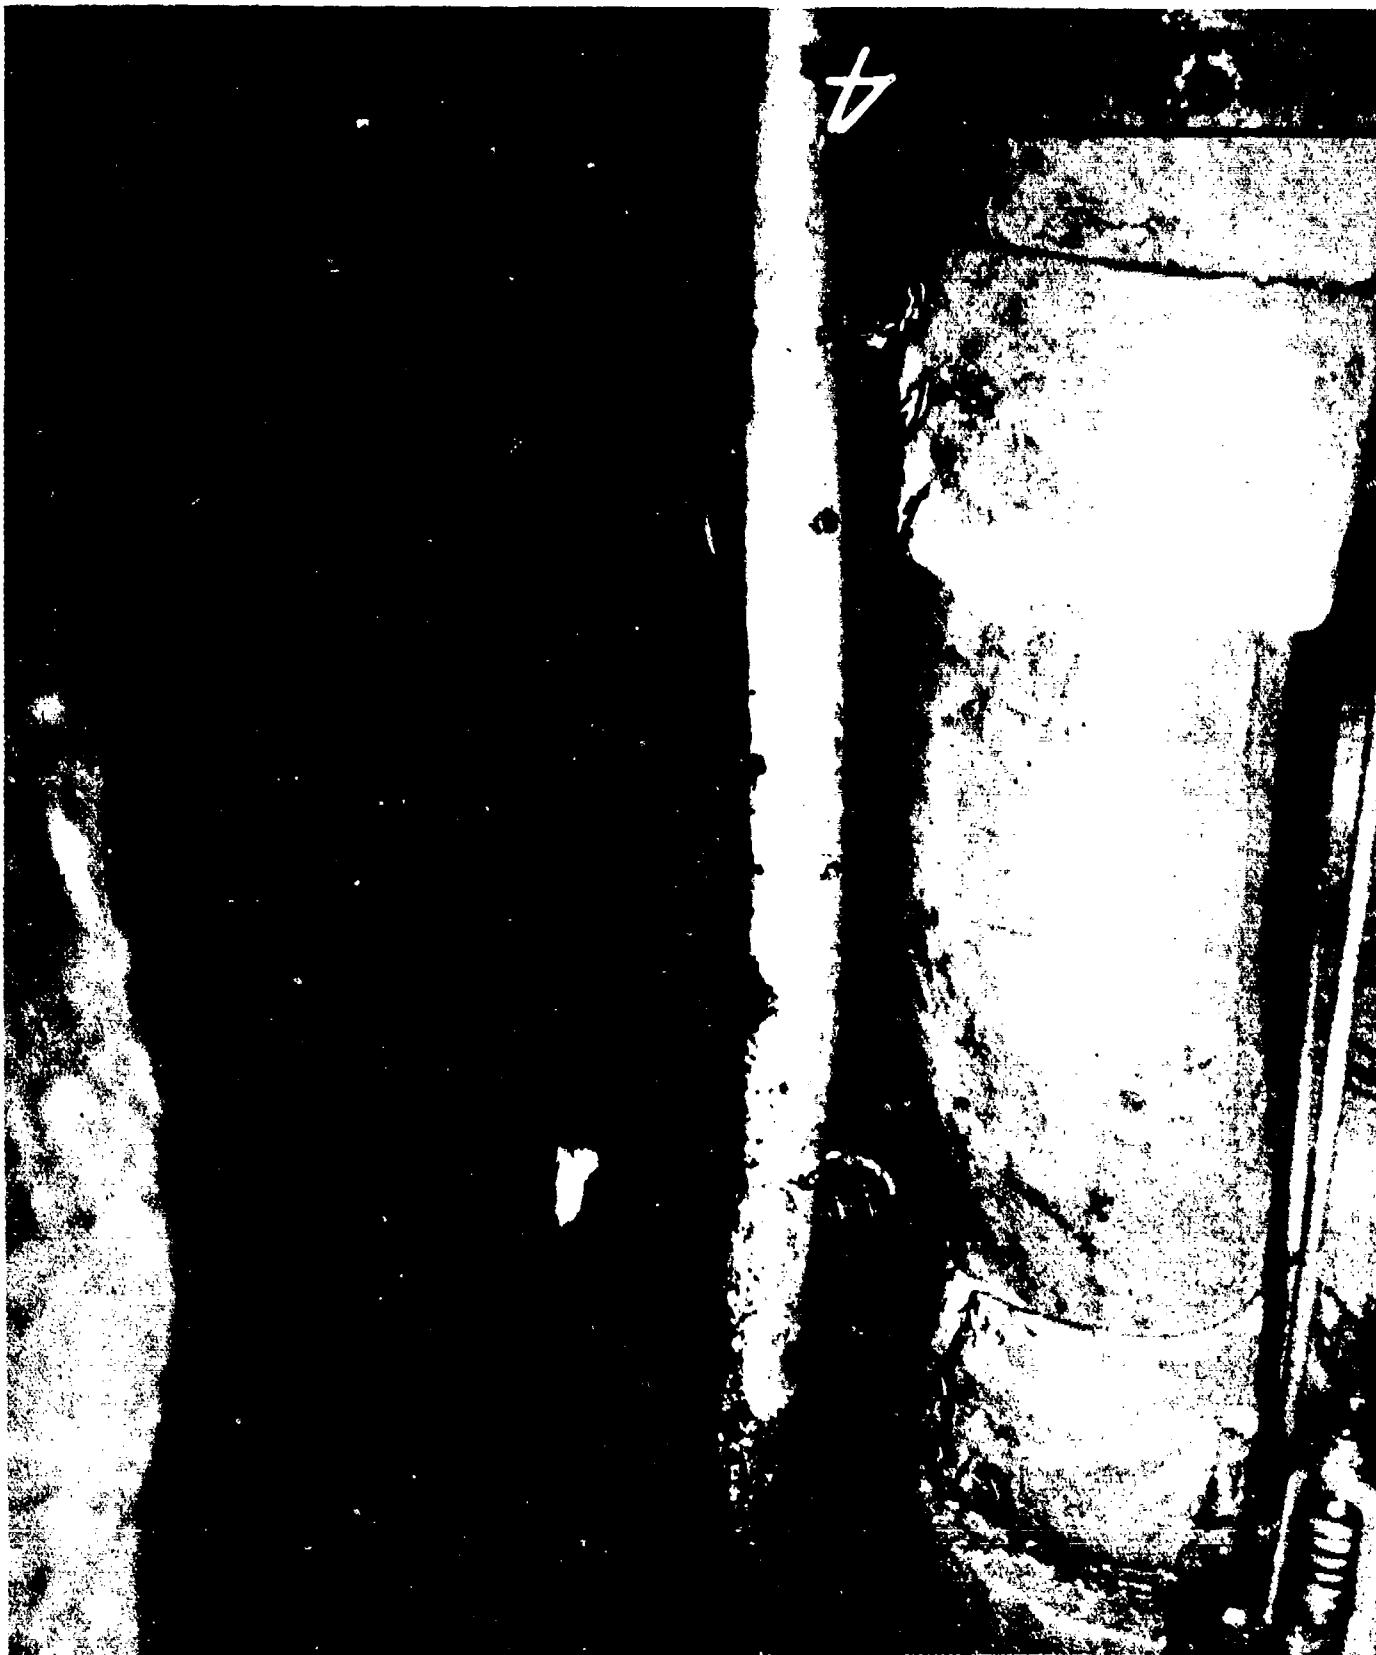
AB-CR-97-4058-4. Aft engine room, B-4-1, 3 1/2" diameter stanchion to port of centerline, frame 128, looking inboard and forward.

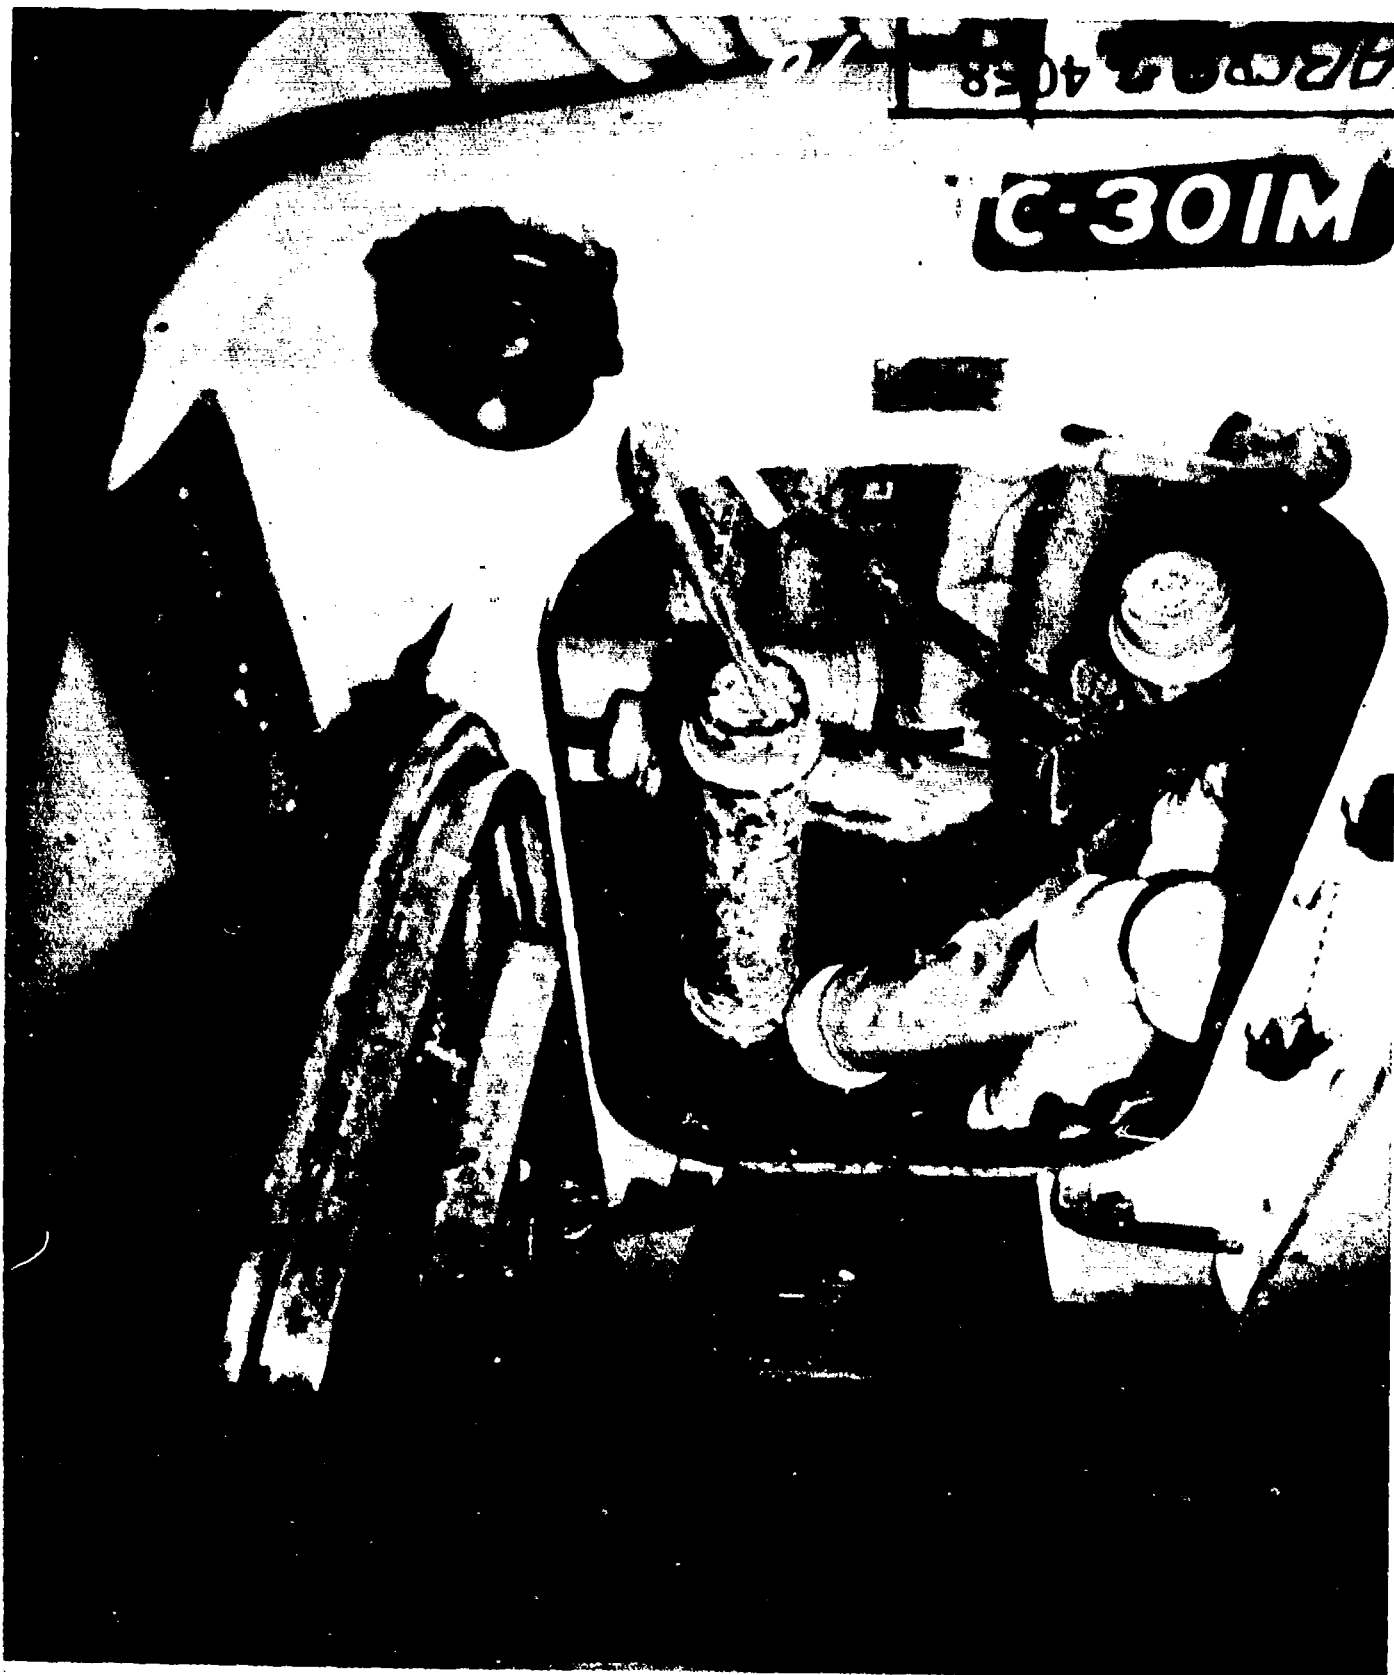
AB-CR-97-4058-10. C-201L. Looking down and aft through 1st platform hatch at frame 146 into 5" handling room C-301M and through door to C-302M, 5" powder.

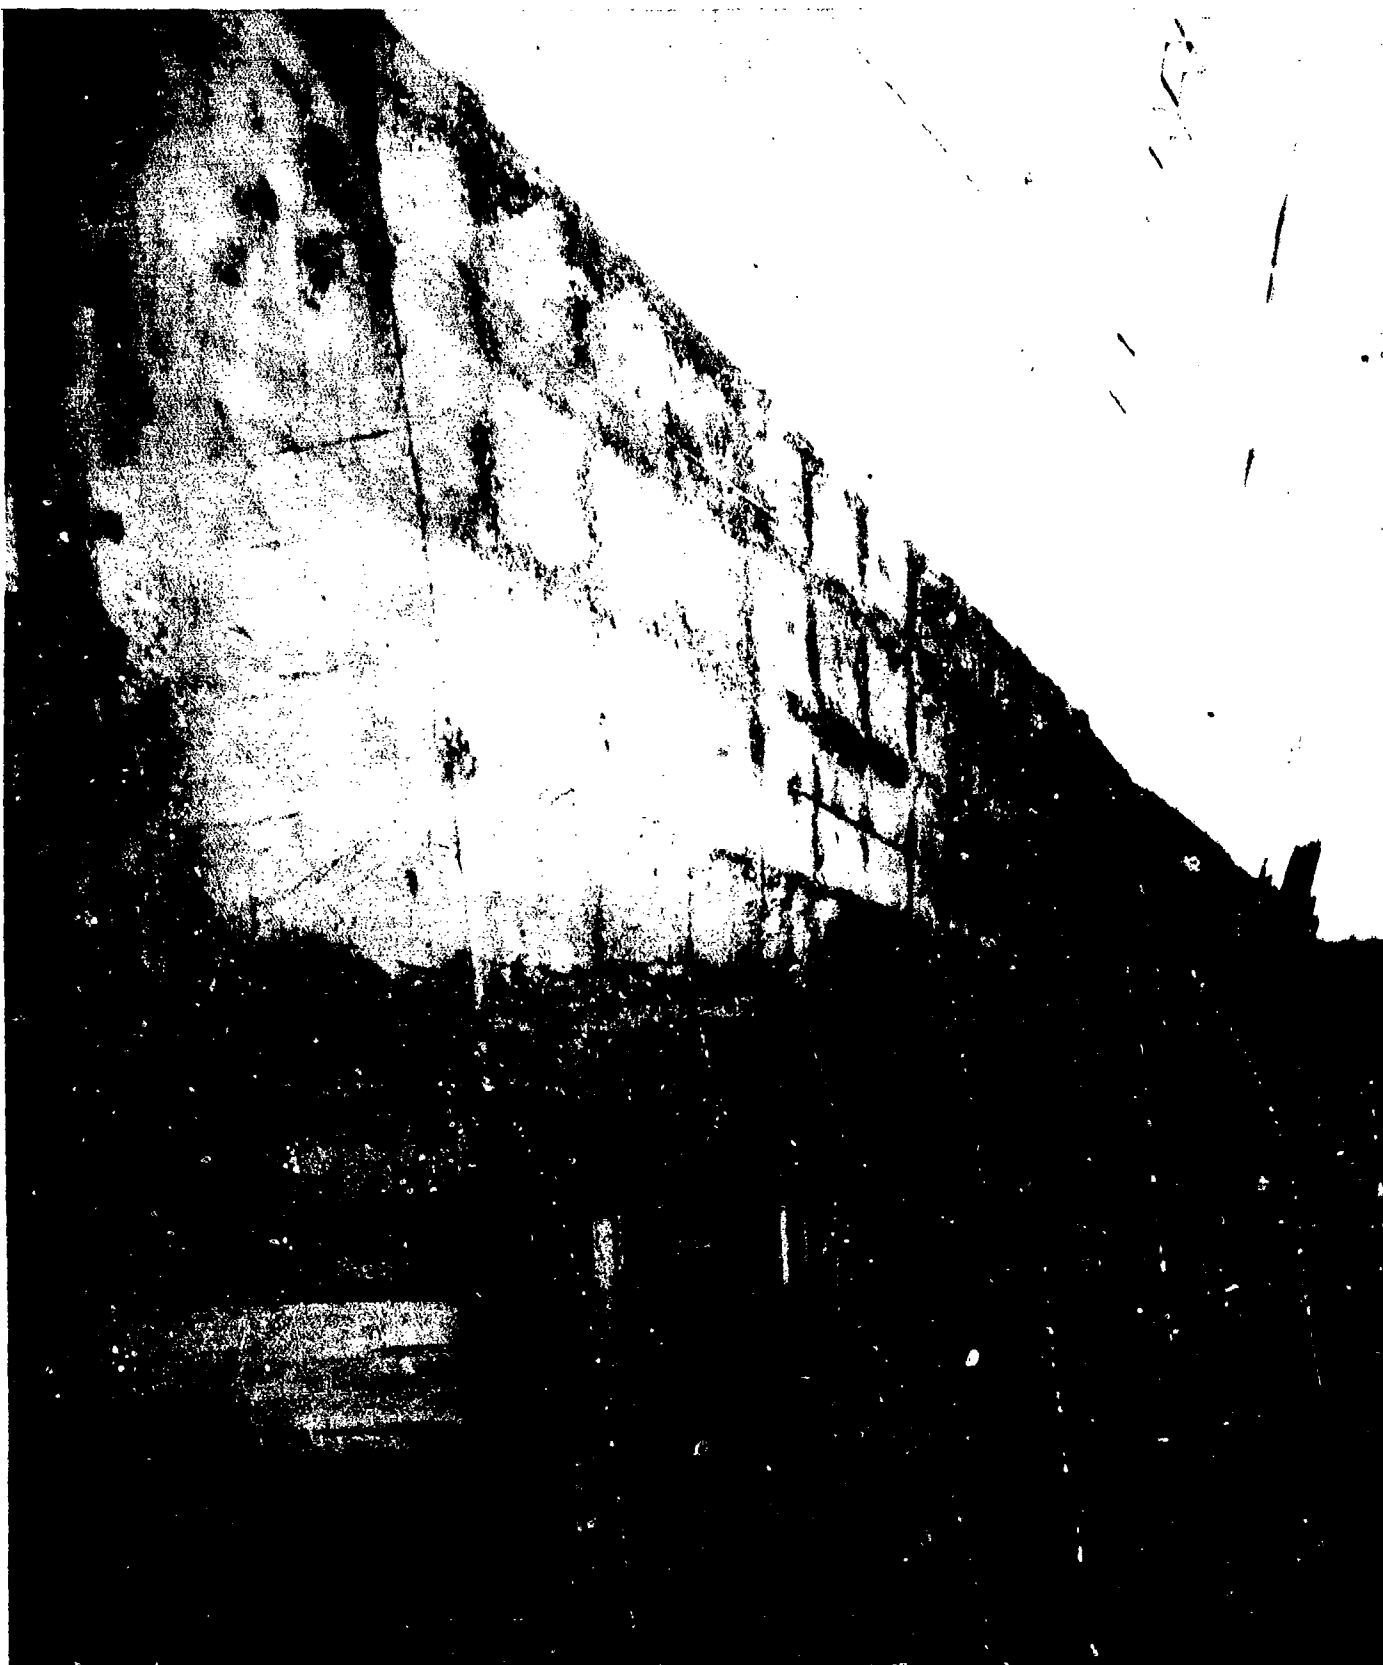
AB-CR-97-4044-12. Port shell looking aft from bow.

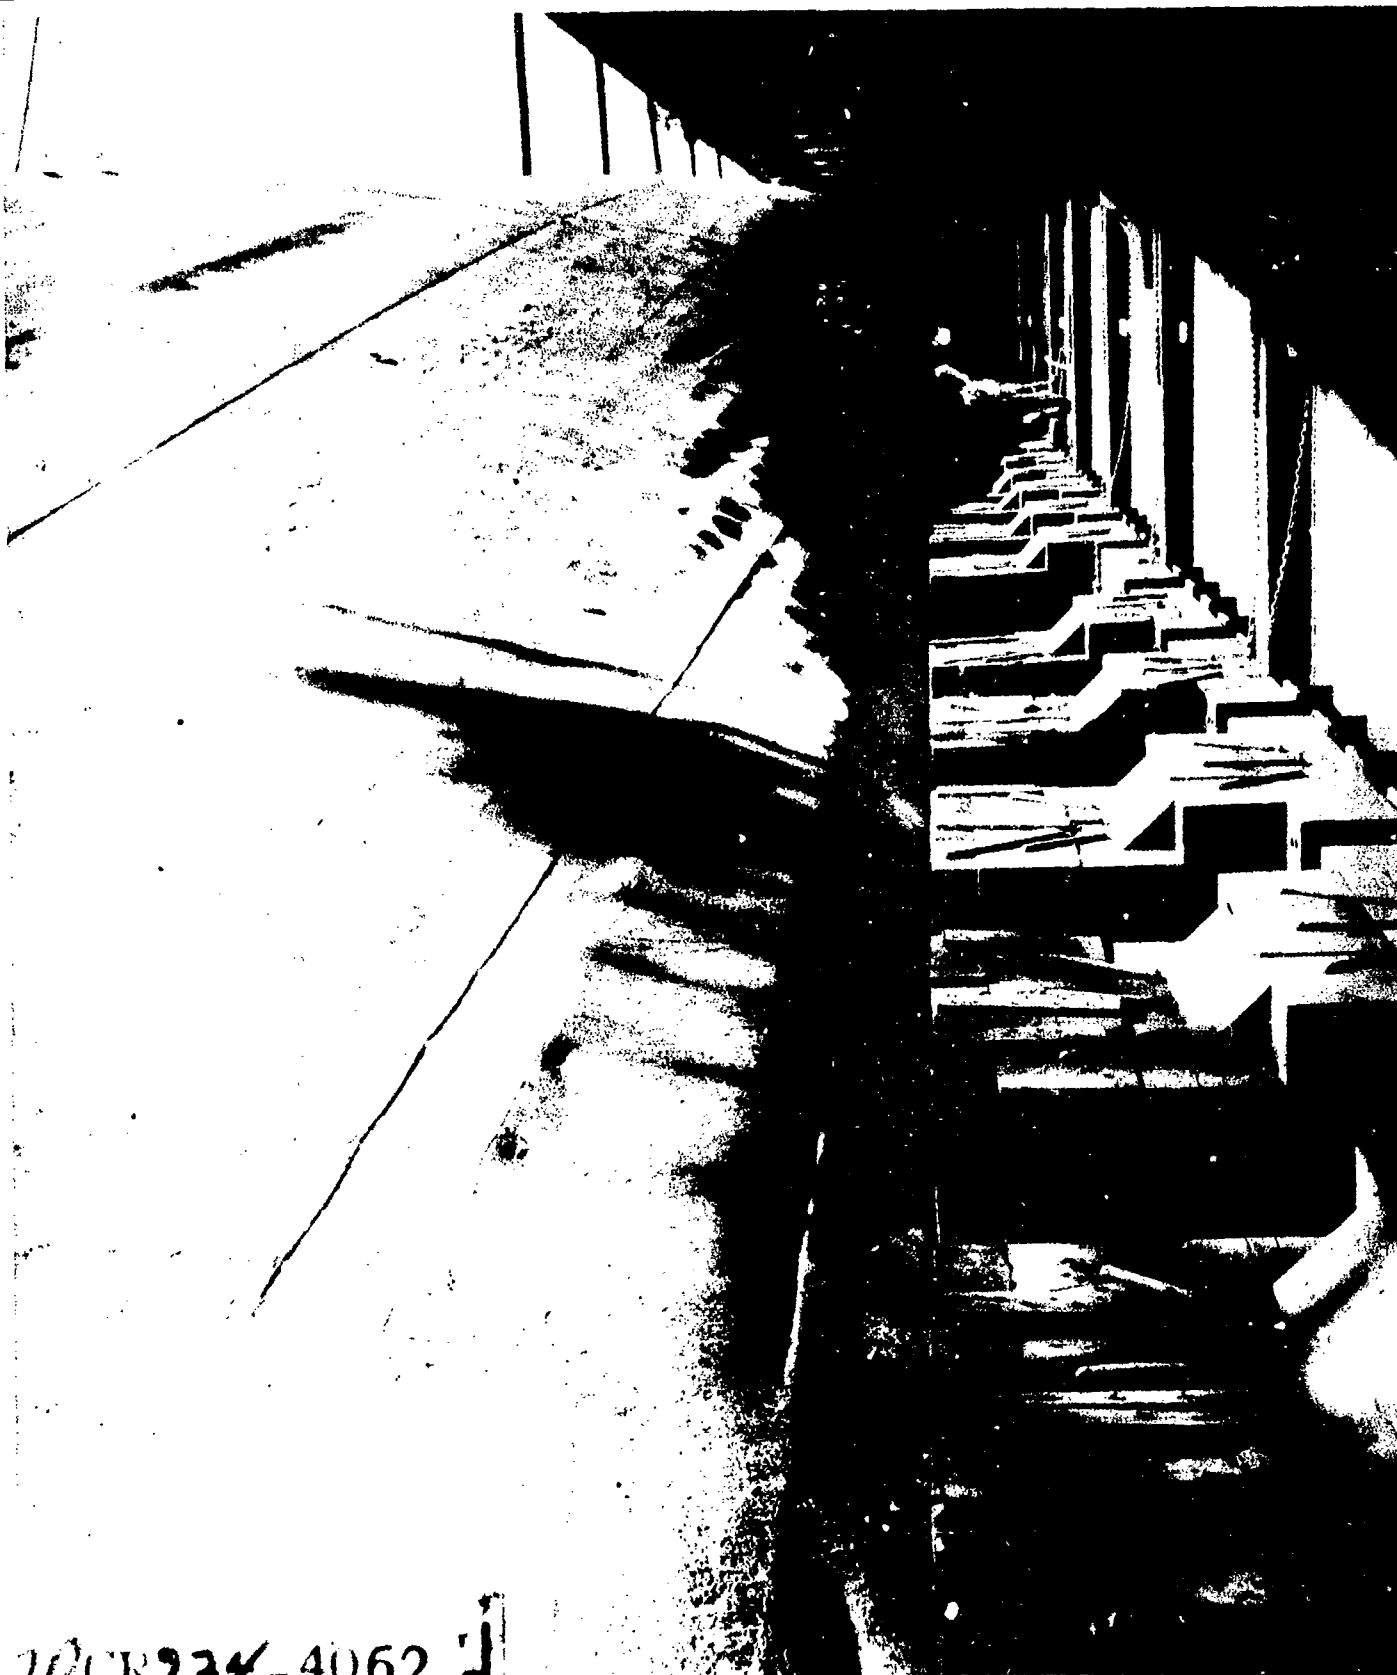
AB-CR-234-4062-5

AB-CR-234-4062-5. Port shell looking aft from bow.

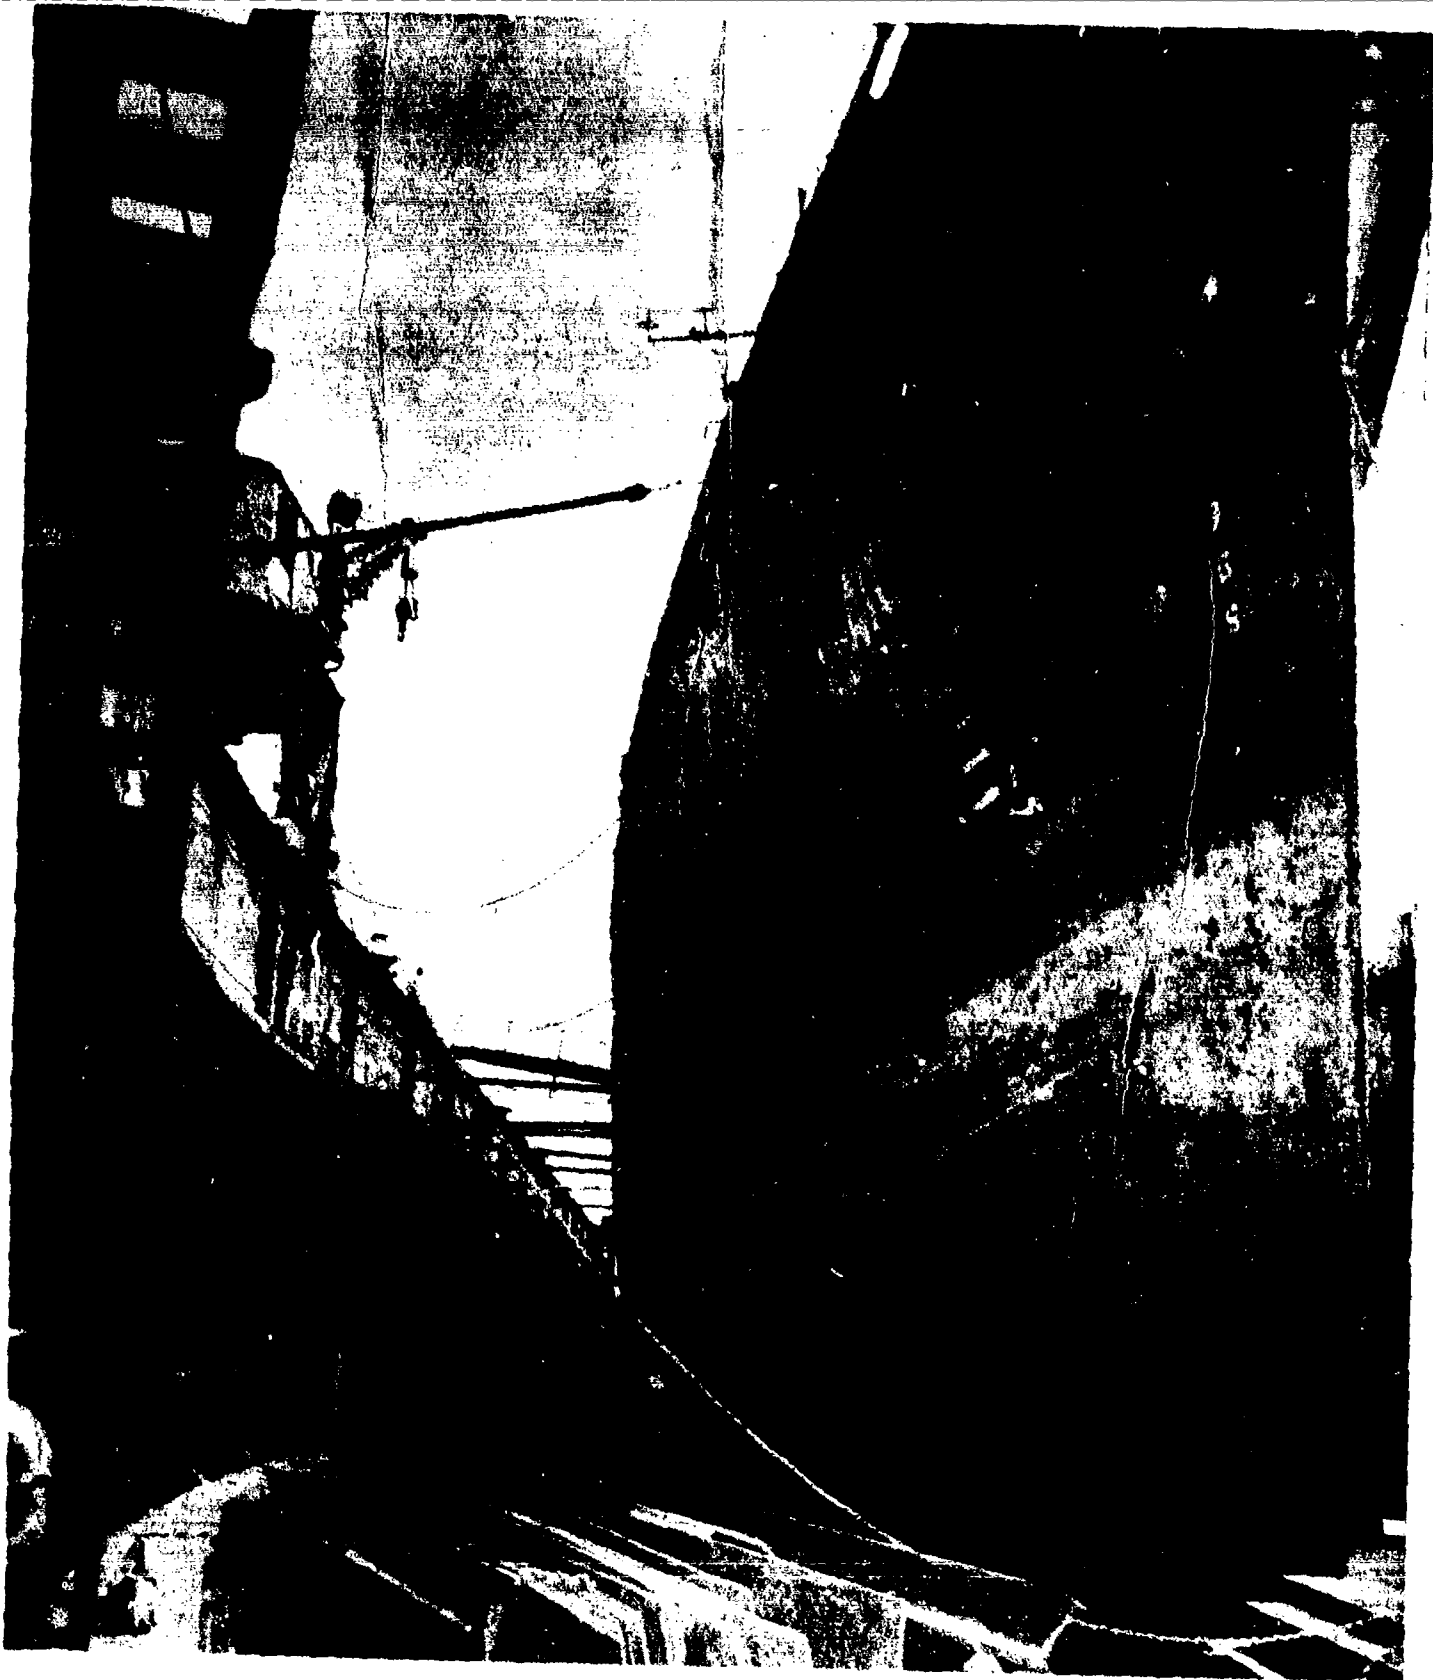
AB-CR-97-4058-1. Starboard shell looking aft from bow.

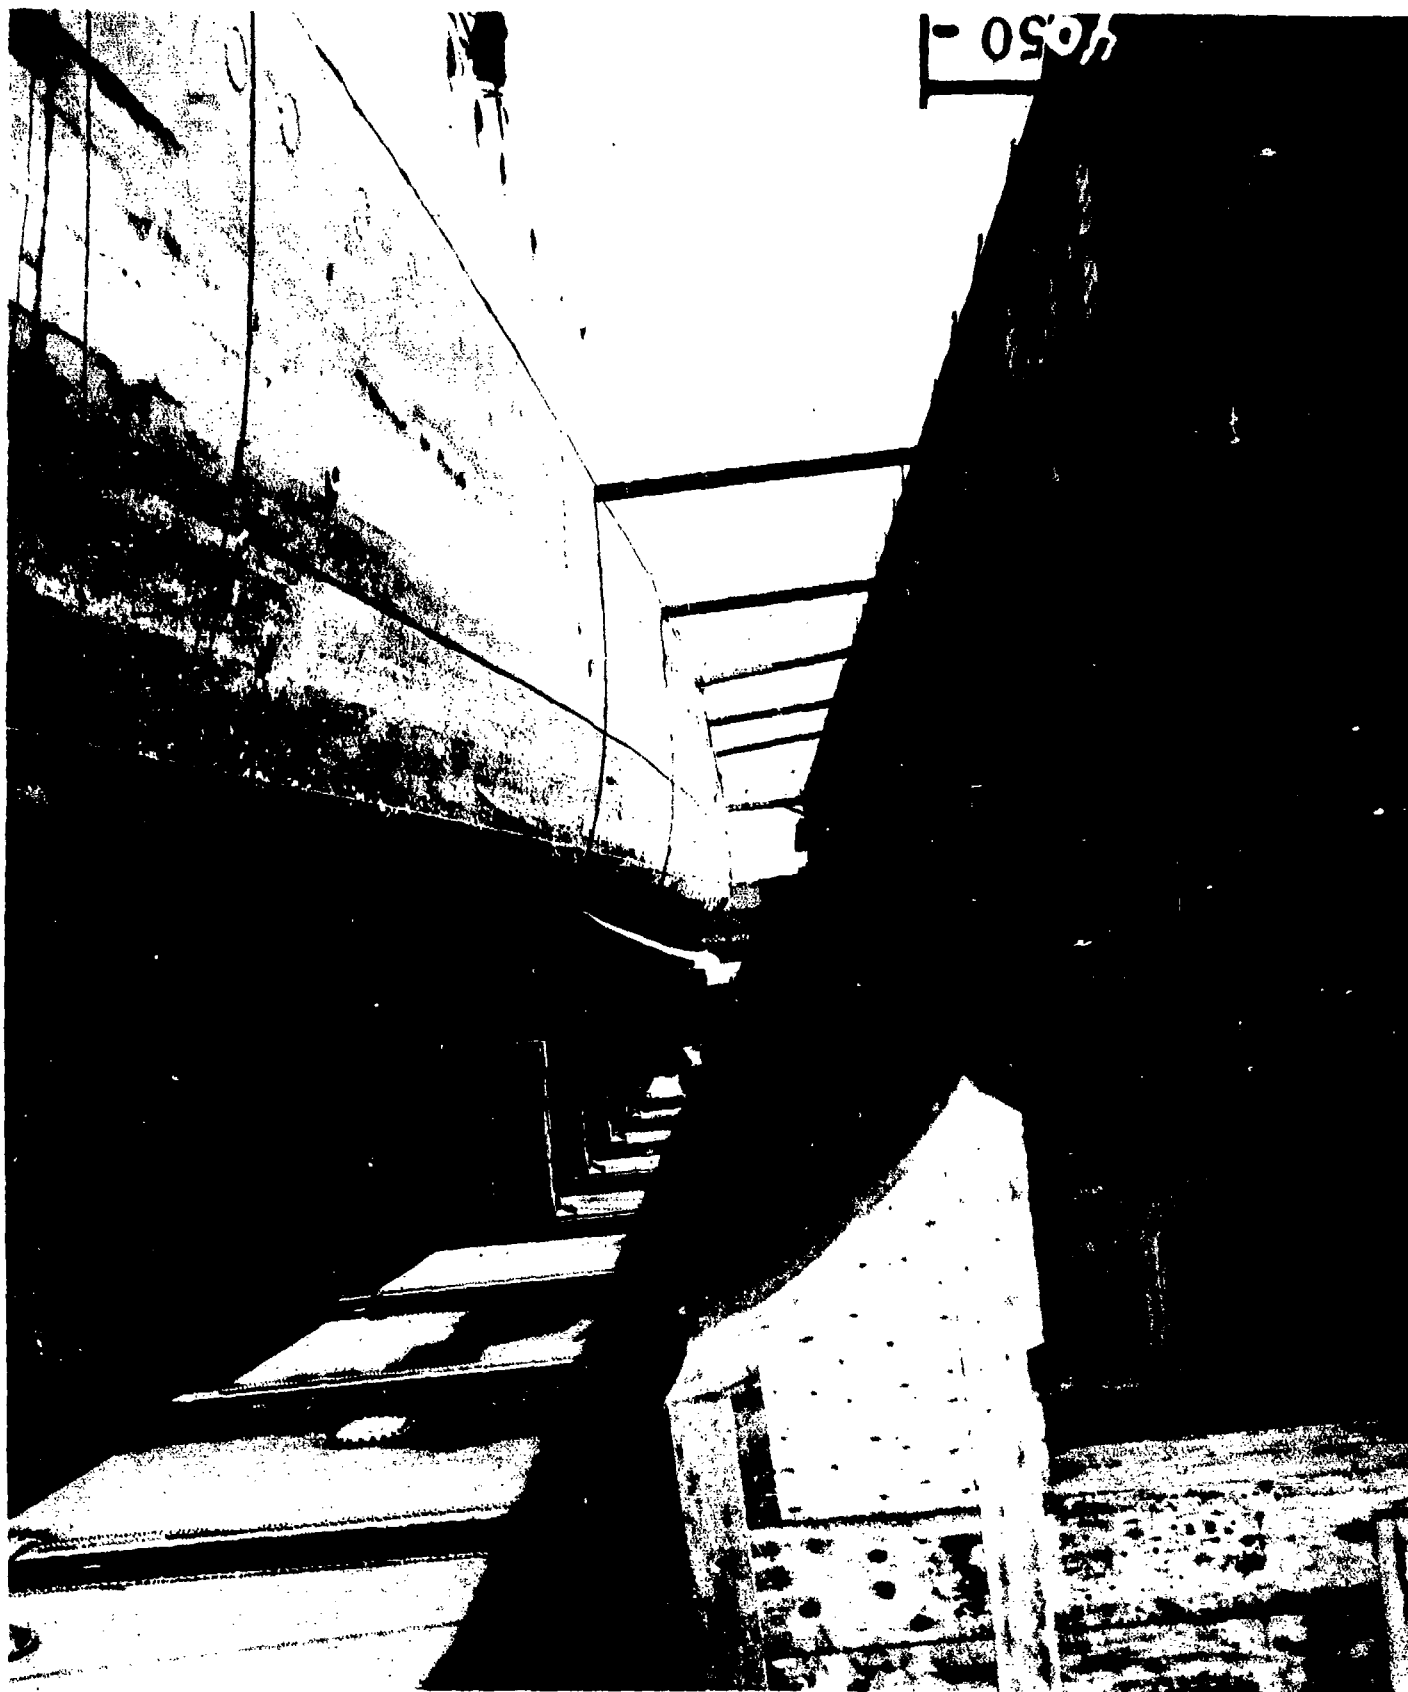
AB-CR-97-4050-10. Port shell looking aft, frames 40-60.
